LAR-IAC2 PROBLEM IDENTIFICATION AND RESOLUTION FORM

PIRF No: L2-4

Data type (Imagery, DEM, DTM, Contours):	Ortho 4-inch
Error type:	Image shift
File name(s):	L2_6440_1826b.jp2 (LARIAC2) and 6440_1826b.jp2 (LARIAC1) comparison
City / community:	City of Culver City
APN / TB page / name of attached shapefile:

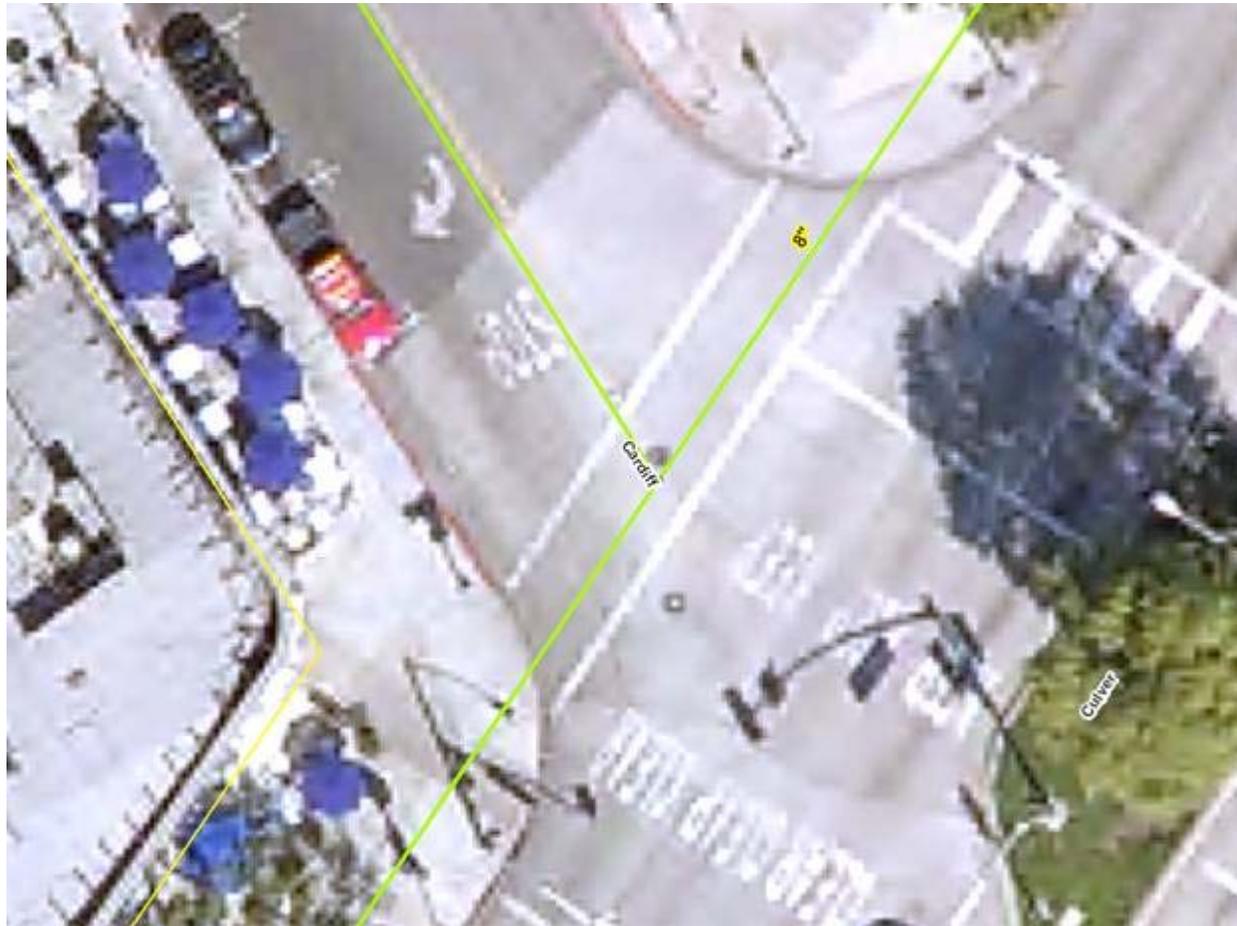
Describe Problem or Map anomaly in detail.
 We throughout numerous areas an inconsistency between the locations of permanent, non-moving features such as manholes. It appears the new imagery may be incorrectly shifted up to ~1 meter. The tile in this PIRF serves as an example, showing manholes in the street, at the intersection of Cardiff Ave and Culver Blvd. Note the green sewer line overlaid at a "T" intersection where a manhole exists as well as the manhole just south of it.

Dewberry has reviewed the issue outlined by Johnnie Griffing of Culver City. All of the horizontal accuracy points falling within Culver City meet the specifications required for the project area. Due to different AT solutions and Camera types for these two projects there is the potential that there may be small differences between the 2006 imagery and the current iteration of imagery with both being within acceptable tolerance. Below are the preliminary results of the horizontal accuracy assessment for Culver City.
